# NASA TECHNICAL MEMORANDUM 89099

# STRENGTH OF A THICK GRAPHITE/EPOXY ROCKET MOTOR CASE AFTER IMPACT BY A BLUNT OBJECT

C. C. POE, JR. AND W. ILLG

FEBRUARY 1987

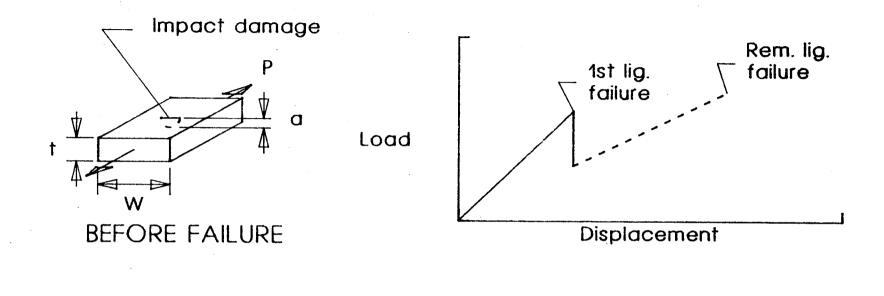
Except for specimens with small impact forces, the impacted specimens failed in two stages as shown in figure 3: first the outer layers with impact damage and then, with increasing load, the undamaged remainder. When the outer layers failed, they also delaminated from the undamaged layers. For each combination of impacter mass and kinetic energy, a duplicate specimen was unloaded when the outer layers failed, removed from the testing machine, and x-rayed. Then, it was reinstalled in the testing machine and loaded to complete failure. Depths of the delaminations in the radiographs were measured.

Impacted specimens. - As shown previously in figure 3, except for small impact forces, specimens failed in two stages: first the outer layers containing the impact damage and then, with increasing load, the remainder. When the outer layers failed, they also delaminated from the undamaged layers. These failures will be referred to as first- and remaining-ligament failures, respectively. For small impact forces, the laminate did not fail in two stages; instead, all layers failed simultaneously. Radiographs of two impacted specimens made before and after loading to first-ligament failure are shown in figures 9(a) and 9(b). Both specimens came from the filled ring, but they are representative of specimens from both rings. The impact forces for specimen 7-7 and 7-8 were 60.0 and 79.2 kN (13.5 and 17.8 kips), respectively. The impact damage caused a visible crater in specimen 7-8, but not in specimen 7-7. A top and a side view are shown in figure 9 for each load condition. In the side views, the dark narrow bands are the hoop layers and the light bands are the helical layers. The delaminations in the radiographs made after loading to first-ligament failure are not confined to a single interface or plane but meander among layer interfaces. Thus, the delaminations do not appear as narrow lines in the radiographs of the sides but as wide dark bands. The innermost path of the delaminations seem to lie at interfaces of hoop and helical layers. It is important for the reader to understand that these delaminations were caused by the loading, not the impacts. The impacts themselves did not cause delaminations.

Figure 3.- Two-part failure with impact damage.

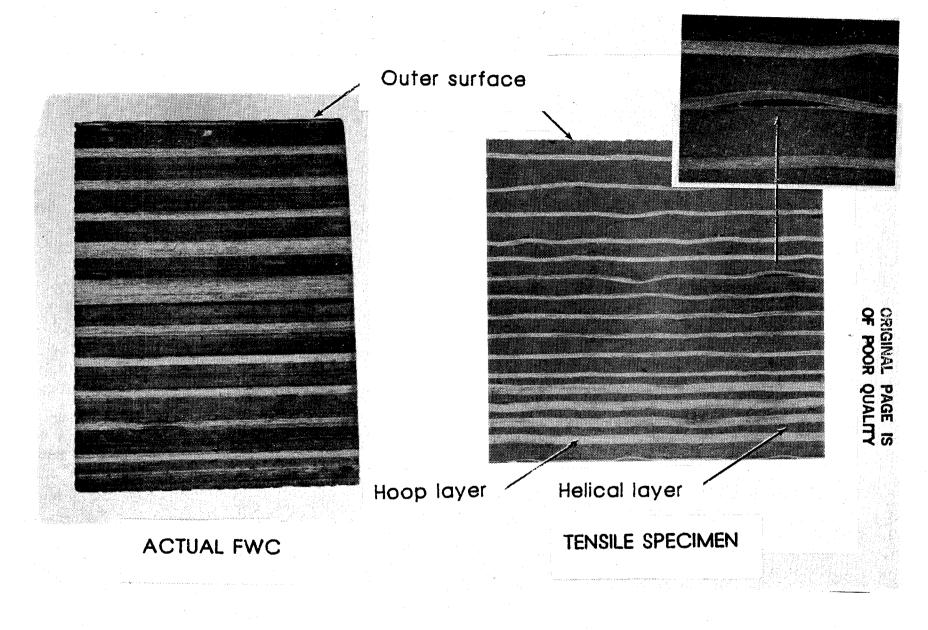
Photographs of an edge of a tensile coupon and a coupon cut from the excess material at the end of an actual FWC case are shown in figure 8. Although the layups are different, notice that the hoop layers (light bands) of the FWC case are straight, but those of the tensile specimen are wavy. The inset shows an enlargement of one wrinkle that is so high the epoxy did not fill in beneath it. These wrinkles are part of a pattern of waviness that occurs throughout all the specimens in varying degrees. It was probably caused when the helical layers were wound over the hand-layed hoop layers, which had no pre-tension.

that the stress concentration factor at the wrinkles was about two. In the tensile specimens here, a stress concentration factor of only 1.6 would account for a 33 percent loss in strength. Thus, the wrinkles in the hoop layers probably caused the low strengths.

Figure 8.- Photographs of edges of a tensile specimen and a coupon from an actual FWC.

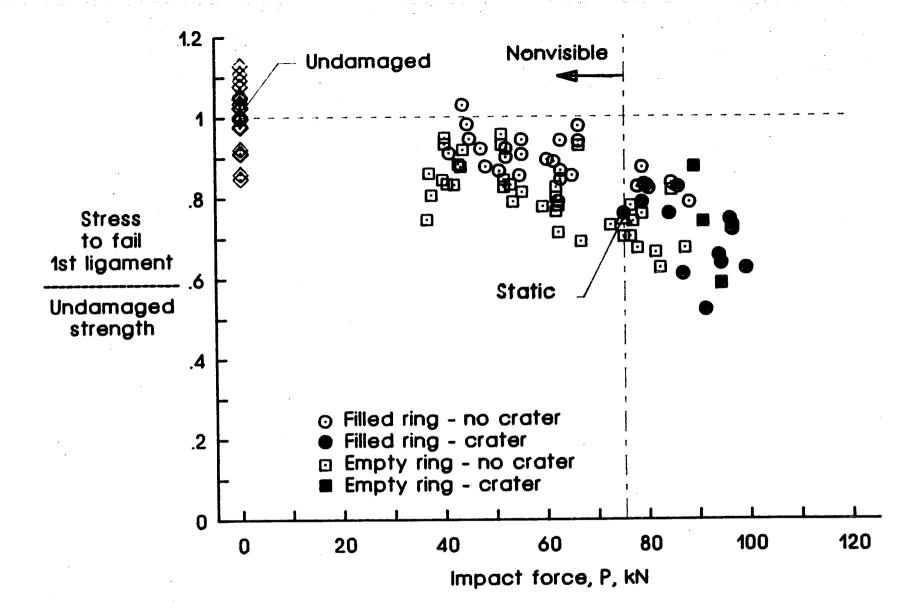
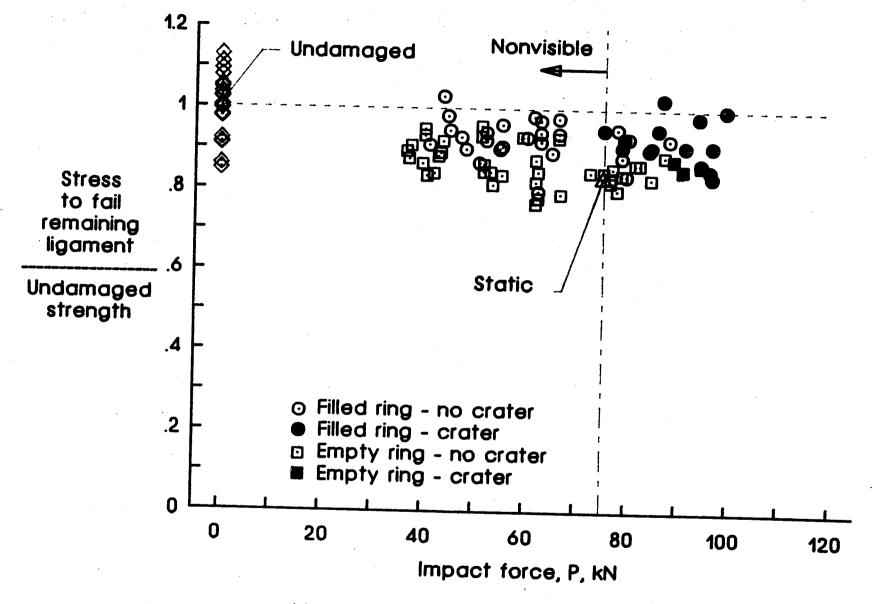
The stresses to fail the first and remaining ligaments were divided by the mean undamaged strength of 345 MPa (50.1 ksi) and plotted in figures 10(a) and 10(b), respectively. Stresses were calculated by dividing the loads by the gross area of the test section, just as they were for the undamaged strengths. When the impact forces were small and the specimens failed in one stage, the strengths were plotted in both figures. Therefore, the failing stresses in figure 10(b) are also the ultimate strengths of all the specimens. Different symbols were used for the empty and filled rings, and the symbols were filled when the impacters made craters. The impact force threshold for visible damage is indicated by the vertical line at 75.2 kN (16.9 kips). The stresses for first-ligament failure decrease with increasing impact force. On the other hand, the stresses for remaining-ligament failure appear to be more independent of impact force, even when the impacters made craters. For the largest impact forces, the stresses for first-ligament failure are as low as 50 percent of the mean undamaged strength. On the other hand, the stresses for remaining-ligament failure are no lower than 75 percent of the mean undamaged strength. At the

threshold for visible damage, the lowest stresses for first- and remaining-ligament failures are 63 and 78 percent of the mean undamaged strength, respectively.

The individual undamaged strengths were also plotted in figures 10(a) and 10(b) for comparison. The failing stresses of the impacted and undamaged specimens overlap considerably. For several specimens, in fact, the stress to fail the remaining ligament is greater than the mean undamaged strength. Nevertheless, the coefficients of variation among specimens with the same impact conditions is not large [2]. It is typically less than 0.1. Also, the failing stresses for specimens from the filled ring are typically 5 to 10 percent higher than those for specimens from the empty ring. It is believed that this difference is caused by material or testing variations and not by the inert propellant.

Figure 10.- Ratio of impact strength to undamaged strength versus impact force.

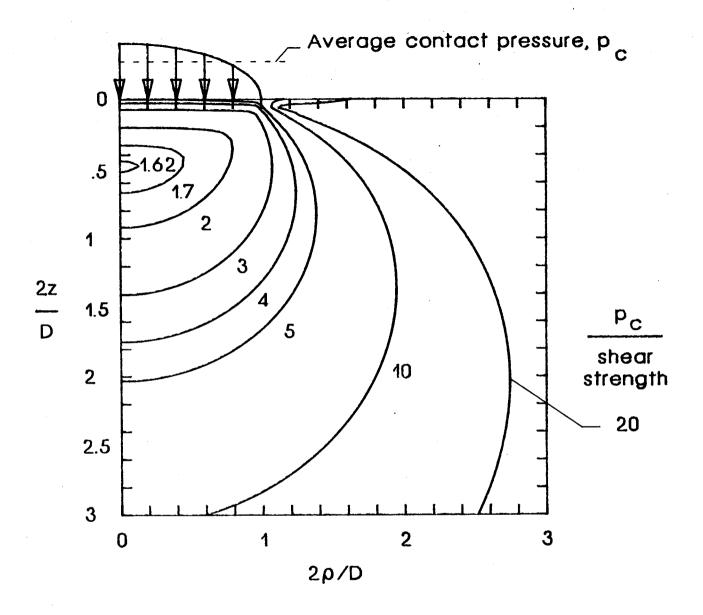
Love's solution gives no tension stresses beneath the contact area. On the other hand, the compression stress in the plane of the fibers is as large as  $(1/2 + \nu_2)p_c$ , where  $p_c$  is the average contact pressure at the center of the contact surface. However, as will be shown subsequently, the observed mode of fiber failure did not appear to be shear kinking or micro-buckling, which is usually associated with compression failures. Therefore, a maximum shear criterion was assumed for failure of the fibers. Principal shear stress contours from Love's solution are plotted in figure 11 for various ratios of average contact pressure to shear strength. These stress contours are equivalent to damage contours. The coordinates z and  $\rho$  are normalized by the contact radius. The average contact pressure  $p_c$  is the impact force

divided by the contact area or  $p_c = P/(\pi D^2/4)$ . The maximum value of the hemispherical pressure is 1.5 times the average value and occurs at  $\rho = 0$ . The contours in figure 11 are approximately circular in cross section, giving a somewhat spherical damage region.

Figure 11.- Damage contours from Love's solution for hemispherical contact pressure.

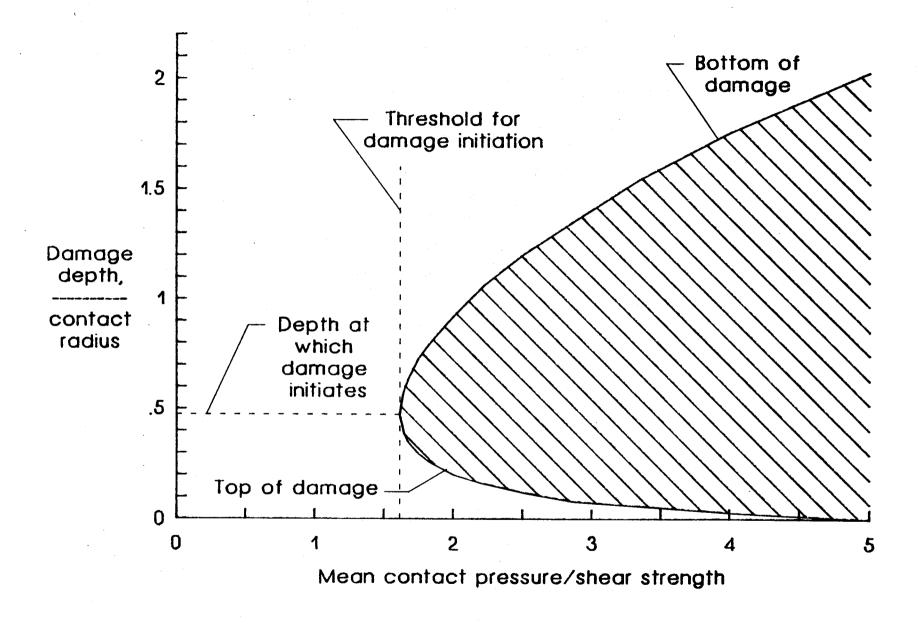
The maximum and minimum depths of the damage contours ( $\rho=0$ ) are plotted against the contact pressure in figure 12. The damaged envelope is crosshatched. Damage initiates below the surface at 2z/D=0.47 when the contact pressure is approximately 1.61 times the shear strength. As the pressure increases, the damage spreads up and down and reaches the surface at a pressure equal to approximately 5.0 times the shear strength.

In order to use the curve in figure 12 to predict the depth of impact damage, the shear strength, the contact radius, and the contact pressure must be known. The contact diameter measured with the carbon paper is plotted against impact force in figure 13. Different symbols were used to indicate when the impacters made craters. (In the empty ring, the contact area was inadvertently not measured for the largest kinetic energy when the impacters made craters.) The paper was obliterated in the contact area when the impacters made craters, and the outline of the area was somewhat ragged. Thus, the dispersion is greater when impacters made craters. For the Hertz law [3], the contact diameter is

Figure 12.- Damage depth versus mean contact pressure according to Love's solution and principal shear criterion for failure.

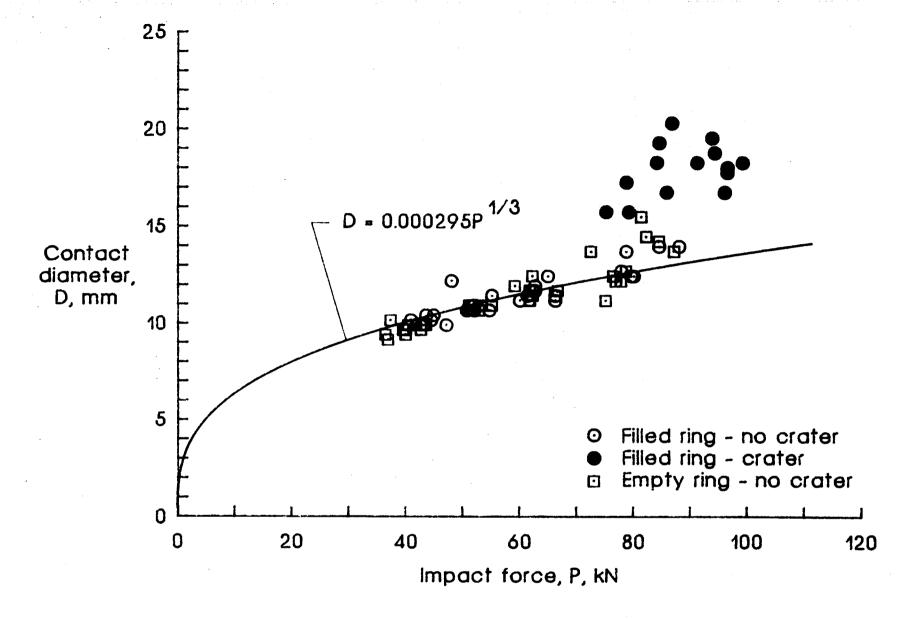
A regression analysis of the data without permanent craters using equation (8) gave  $n = 448 \text{ MN/m}^{3/2}$  (408 kips/in.  $^{3/2}$ ). Equation (8) models the contact diameters in figure 13 very well except when the impacters made craters. Then,

Figure 13.- Contact diameter versus impact force.

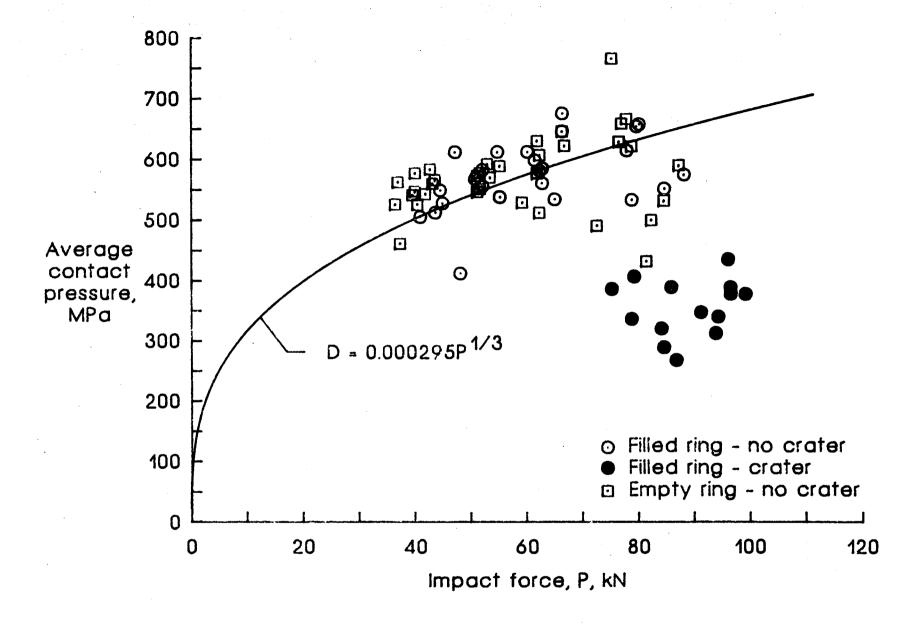
The impact forces divided by the circular contact area  $\pi D^2/4$  are plotted against impact force in figure 14. Different symbols were used when impacters made craters. Without craters, the pressures are 480 to 690 MPa (70 to 100 ksi). (Recall that the peak value of the hemispherical pressure in Love's solution is 50 percent greater than the values in figure 14.) When craters were made, the contact diameters increased so much that the pressures dropped about 40 percent. Eliminating the contact diameter in equation (8) with  $D = \left[4P/(\pi p_c)\right]^{1/2}$  and solving for the average contact pressure  $p_c$ ,

Equation (9) with  $n=448 \text{ MN/m}^{3/2}$  (408 kips/in.  $^{3/2}$ ) is also plotted in figure 14. The calculated pressures and equation (9) agree likewise. Notice that both contact diameter and pressure increase in proportion to impact force to the 1/3 power.

Figure 14.- Average contact pressure versus impact force.

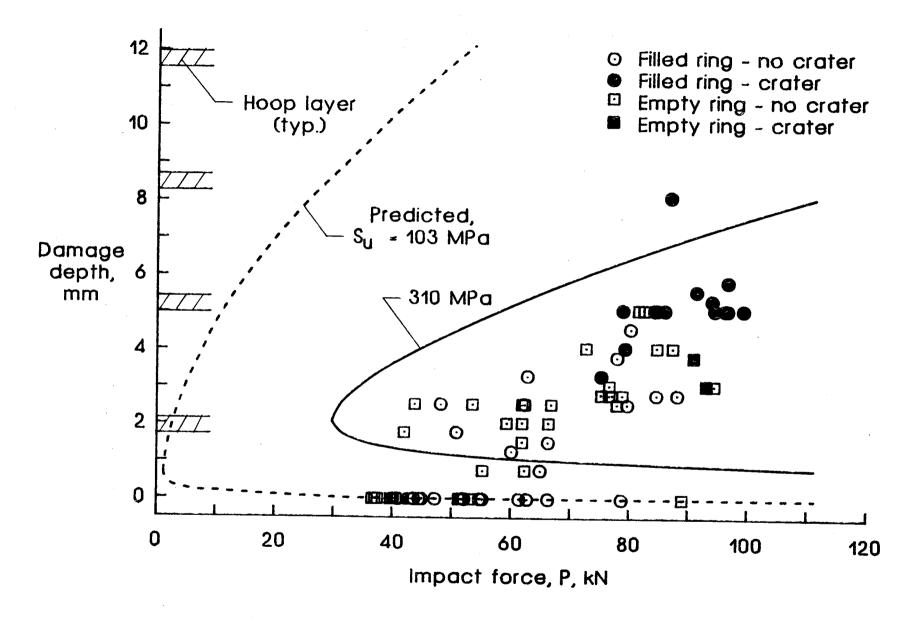
The depths of impact damage revealed in the radiographs are also plotted in figure 16. Filled symbols were used to indicate when the impacters made craters. The depths are very similar in the filled and empty rings for the same impact force. The damage was not evident in the radiographs for impact forces less than 40 kN (9 kips). The damage was not always evident for impact forces between 40 (9 kips) and 89 kN (20 kips). However, it was always evident when impacters made craters. In general, damage depth in the radiographs increased with impact force above 40 kN (9 kips) and did not extend below the second hoop layer.

If the dye penetrated to the innermost matrix damage, the depth of damage in the radiographs should correspond to the predicted curve for matrix damage. However, it does not; the depths in the radiographs correspond more to the predicted curve for fiber damage. Actually they are a little less than the curve for fiber damage. Radiographs were made of a specimen with an impact force of 81.4 kN (18 kips) before and after a small hole was drilled deep into the impact site [1]. There was no visible surface damage. The radiograph made before the hole was drilled also did not reveal damage. However, the radiograph made afterward did. Therefore, the dye apparently has difficulty penetrating the damage. Also, the damage depths are probably overpredicted somewhat because isotropic theory gives larger stresses than anisotropic theory [3]. On the other hand, the impact force threshold for appearance of damage in the radiographs does agree fairly well with the force at which the predicted matrix damage reaches the surface. However, the force threshold for causing craters, which is about 75.2 kN (16.9 kips), is an order of magnitude less than 907 kN (204 kips) that is predicted for the fiber damage to reach the surface.

Figure 16.- Comparison of predicted impact damage and radiographs.

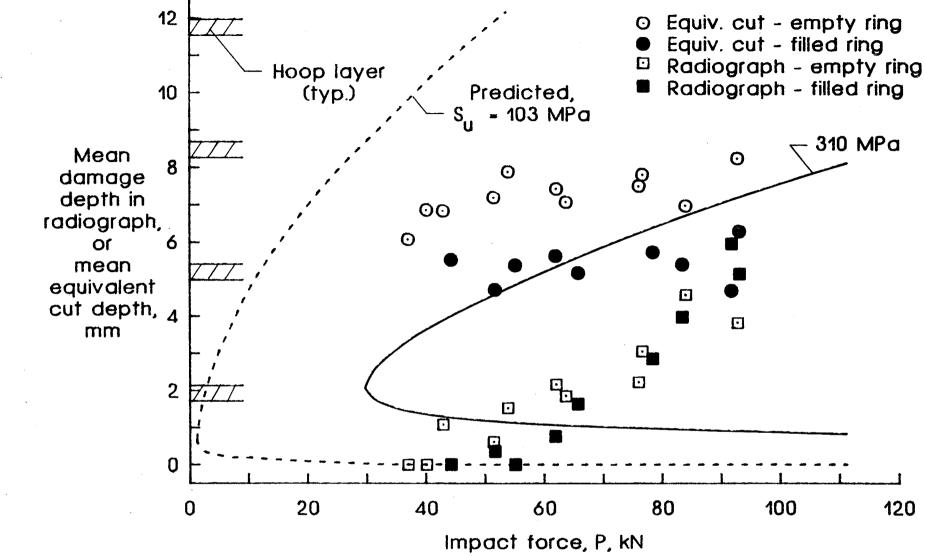
The average depths of impact damage in the radiographs made before loading are also plotted in figure 17 for comparison. For small impact forces, the damage depths in the radiographs are much less than the equivalent cut depths. But, for large enough impact forces to cause craters, the damage depths are more nearly equal to the equivalent cut depths. Therefore, the radiographs reveal much less impact damage than that implied by the remaining-ligament strengths when there is no surface damage. Although the values of equivalent cut depth were smaller for the filled ring than the empty ring, the damage depths in the radiographs were not.

Figure 17.- Comparison of equivalent cut depth and radiographs. (Test values are averages of more than one test.)

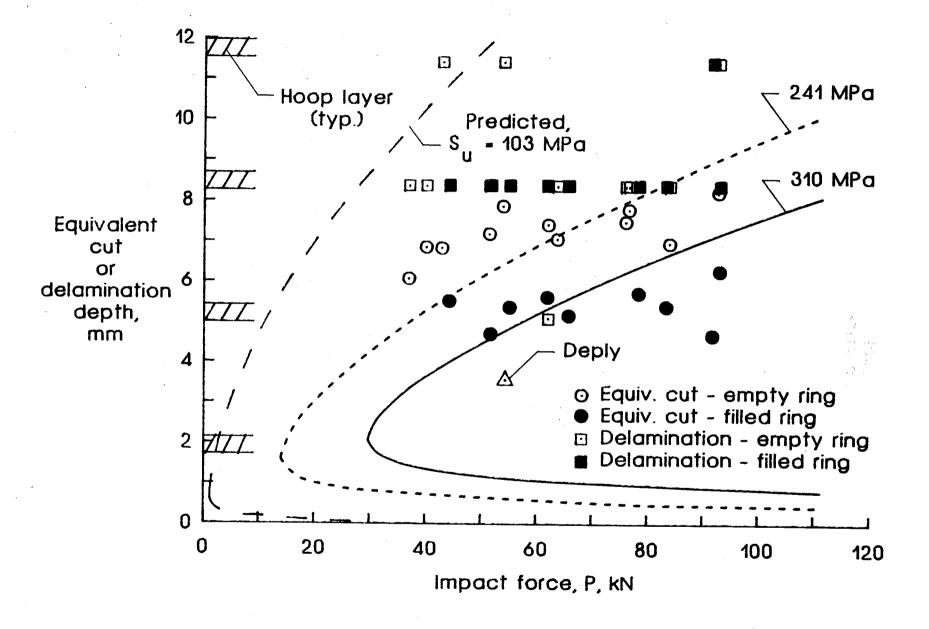
The depths of delaminations in the radiographs were measured and plotted against impact force in figure 18. Average values of equivalent cut depths were also plotted for comparison. (The delamination depths are not averages.) The filled symbols represent the filled ring and the empty symbols represent the empty ring. If impact damage is equivalent to a surface cut, one would expect the delamination depths to be deeper than the equivalent cut depths by no more than half the thickness of a group of helical layers. This was true for specimens from the empty ring, indicating that the delamination and equivalent cut depths were consistent. For specimens from the filled ring, the delamination depths were a full thickness of helical layers below the equivalent cut depths. As noted previously, the specimens from the filled ring were 5 to

10 percent stronger than those from the empty ring, and the equivalent cut depths were correspondingly less. Because the damage depths in the radiographs were equal for the filled and empty rings and the delamination depths were equal for the filled and empty rings, the difference between strengths of the filled and empty rings is probably due to material variation or load measurement error rather than impact damage. Nevertheless, the equivalent cut depths and the delamination depths both indicate that the radiographs made before loading do not reveal the full extent of impact damage, even when the impacts caused craters.

The depth of the "cracked" layer in figure 19 was also plotted in figure 18 for the corresponding impact force and labeled "deply". It is less than the equivalent surface cuts and delaminations. However, it is almost as deep as the predicted curve for 310 MPa (45 ksi), which corresponds to fiber failure. Perhaps fibers below the "cracked" layer in figure 19 were weakened but not visibly broken in the deplied layers, causing lower remaining-ligament strengths. Elber [4] found evidence to this effect. He removed fiber bundles from the impact site of a thin graphite/epoxy laminate and loaded them to failure. The strengths of some bundles were 30 to 50 percent of the undamaged strength without a corresponding number of visibly broken fibers (private communication from Dr. Elber, U.S. Army Aerostructures Directorate, USAARTA - AVSCOM, Langley Research Center, Hampton, Virginia).

Figure 18.- Comparison of equivalent cut depth and delamination depth. (Test values are averages of more than one test.)
